**BIOMONITORING OF RIVERS
AT SIBANYE**

FACT SHEET

March 2017

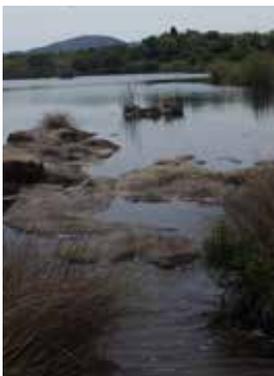
1 SITE SELECTION IS BASED ON:

- Water use being assessed
- Accessibility
- Presence of suitable sampling habitat
- Good representativity of entire river
- Availability of historical data

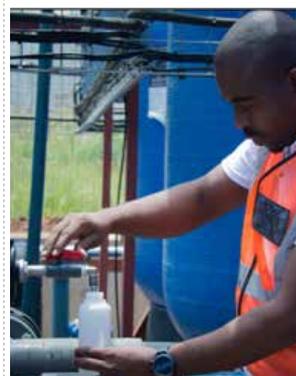
2 WATER QUALITY MONITORING:

- Hand-held water quality meters are used for on-site monitoring of: alkalinity, conductivity, dissolved oxygen and total dissolved solids
- Water samples are taken for laboratory analysis of salts, nutrients and metals, as per the requirements of the DWS

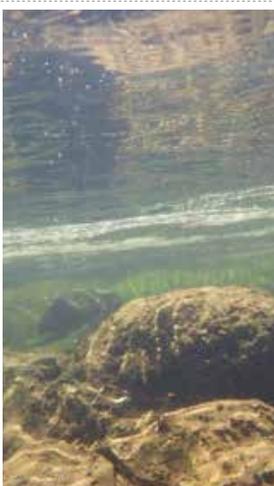
3 HABITAT MONITORING

- Site-specific monitoring of biotopes includes assessment of the suitability of invertebrate habitats. The biotopes monitored are:
 - stones
 - vegetation
 - gravel
 - sand
 - mud
- Reach-based assessments conducted of state of riparian and instream habitats

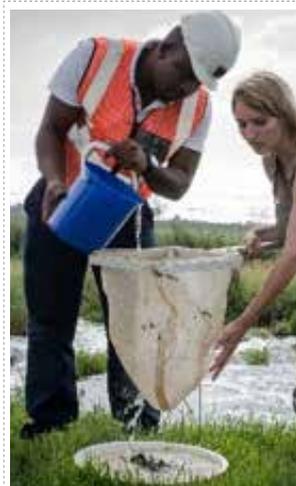
4 AQUATIC MACROINVERTEBRATE MONITORING

- Site-specific assessment of macro-invertebrate assemblage by sampling biotopes
- Reach-based assessment of macroinvertebrates based on site-specific data

(Macroinvertebrates are animals visible on the river bed.)

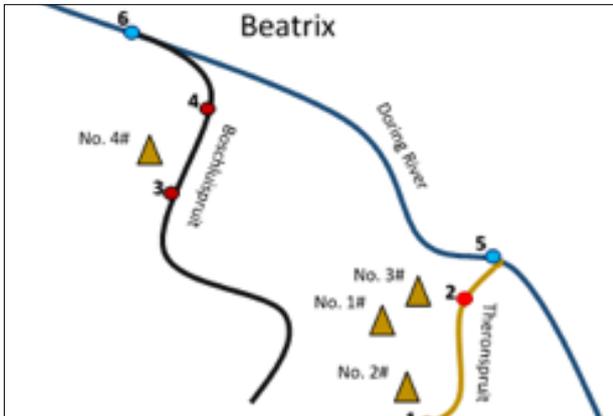
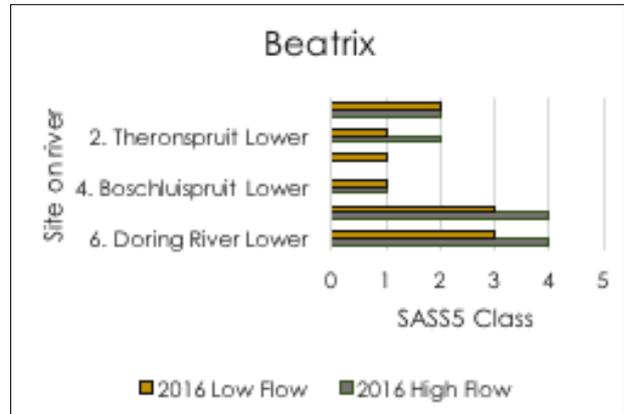
Beatrix

Mine	Catchment	Results	Interpretation
BEATRIX	Theronsspruit	Largely modified	<ul style="list-style-type: none"> Habitat deterioration due to farming and flooding during the low flow season
	Boschluisspruit	Critically modified	<ul style="list-style-type: none"> Upper reaches typically have very low flow Water quality and habitat impacted by mining and surrounding land-use
	Doring River	Largely natural	<ul style="list-style-type: none"> Good habitat and water quality System impacted by a flood event in the low flow season

The graphs below indicate the SASS5 results for each site (per mine and per river reach) for the high and low flow assessments in 2016. NA indicates that the site could not be assessed during that season.

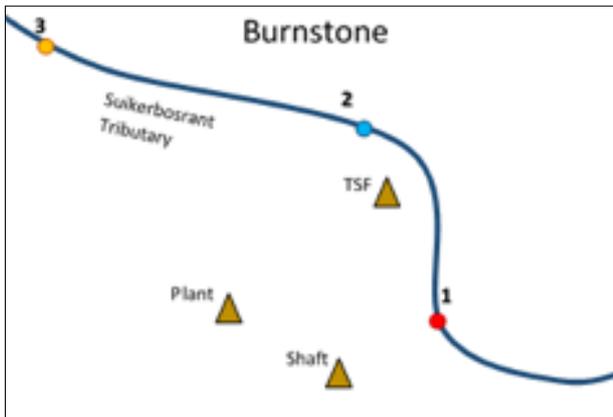
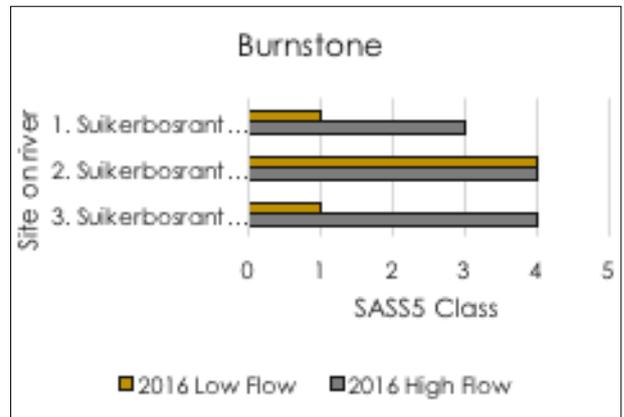
Burnstone

Mine	Catchment	Results	Interpretation
BURNSTONE	Suikerbosrant Tributary	Moderately modified to largely natural	<ul style="list-style-type: none"> No detectable impacts from mining activities Large wetland system limits habitat availability Very low flow impacted results of low flow assessment

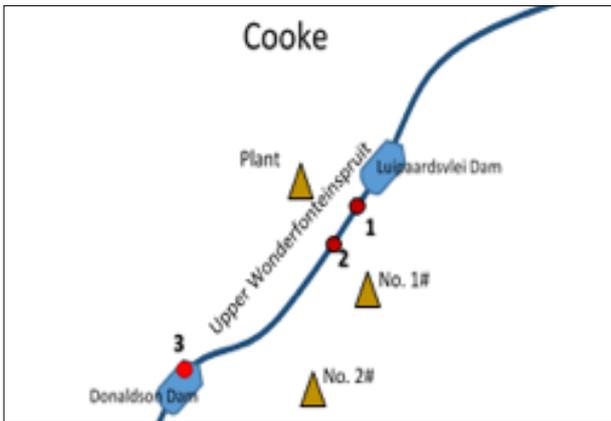
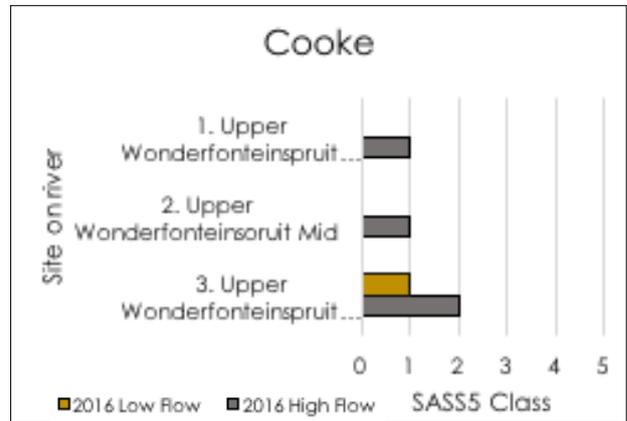
Cooke

Mine	Catchment	Results	Interpretation
COOKE	Upper Wonderfontein spruit	Critically modified	<ul style="list-style-type: none"> Water quality severely impacted by sewage Water quality also affected by mine water discharges Sampling in the uppermost reaches not possible during low flow due to excessive and toxic sewage inflow

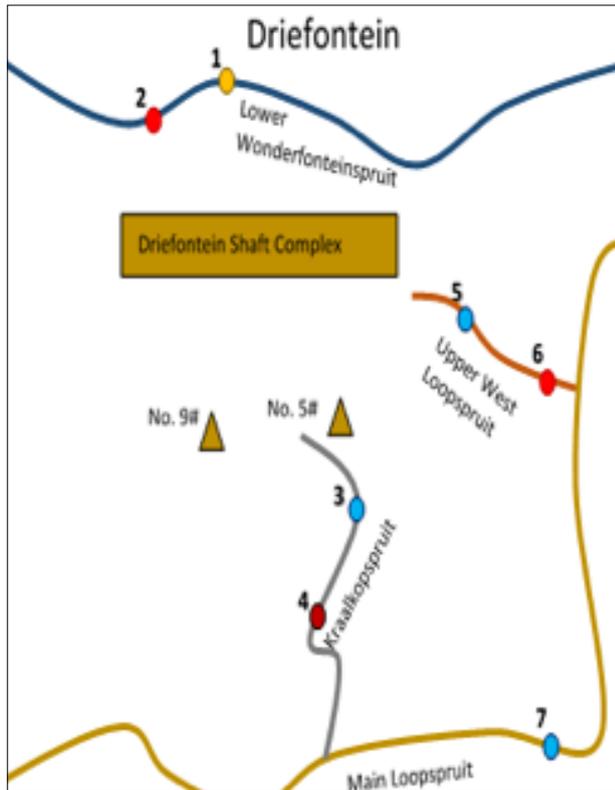
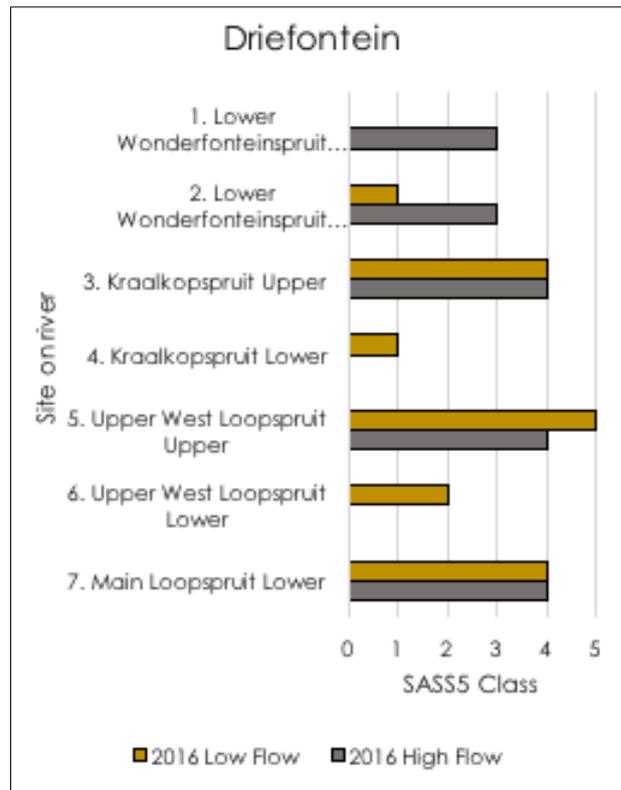
Mine	Catchment	Results	Interpretation
DRIEFONTEIN	Lower Wonderfonteinspruit	Largely modified	<ul style="list-style-type: none"> Habitat significantly impacted by the 1m Ø pipeline* and channels Change in the river's flow route during low flow caused upstream site to be dry Water quality impacted primarily by sewage inflows but also by mining discharges Habitat alterations due to overgrazing
	Kraalkopspruit	Moderately modified	<ul style="list-style-type: none"> Upstream site in largely natural condition Impacts from mining are minimal Drought affected the downstream site, reducing habitat availability and flow significantly Agricultural practices influenced water quantity and quality
	Upper West Loopspruit	Moderately modified to largely natural	<ul style="list-style-type: none"> Reference stream for Upper Vaal sites at Sibanye – not affected by mining activities Good habitat and water quality Poor results at downstream site due to very limited flow

Main Loopspruit	Largely natural	<ul style="list-style-type: none"> Good habitat Not influenced by Driefontein mining activities

* This is a well-known historical pipeline in the Wonderfonteinspruit, installed to prevent flooding of the dolomitic areas to enable mining and reduce the risk of sinkholes in the area.

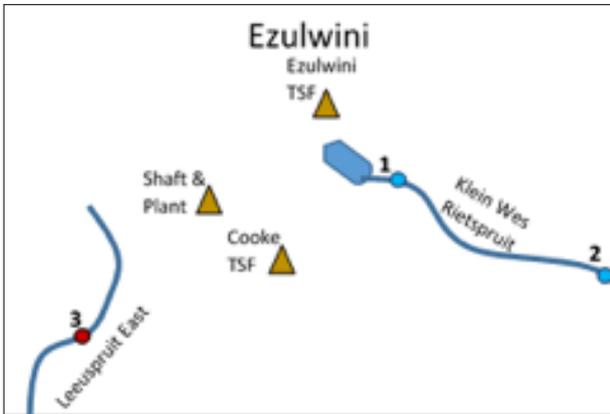
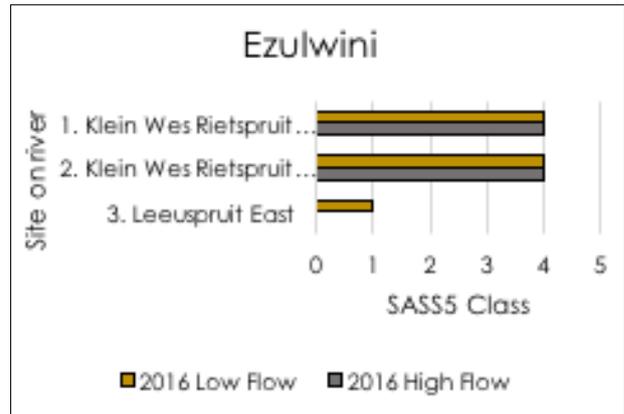
Ezulwini

Mine	Catchment	Results	Interpretation
EZULWINI	Klein Wes Rietspruit	Largely modified	<ul style="list-style-type: none"> Stream in fair condition owing to good flow resulting from underground mine water discharges Water quality impacted by mining and sewage, surrounding communities and agricultural activities
	Leeuspruit East	Critically modified	<ul style="list-style-type: none"> Stream in poor condition due to intermittent and low flows Habitat has been altered, possibly a result of illegal mining activities

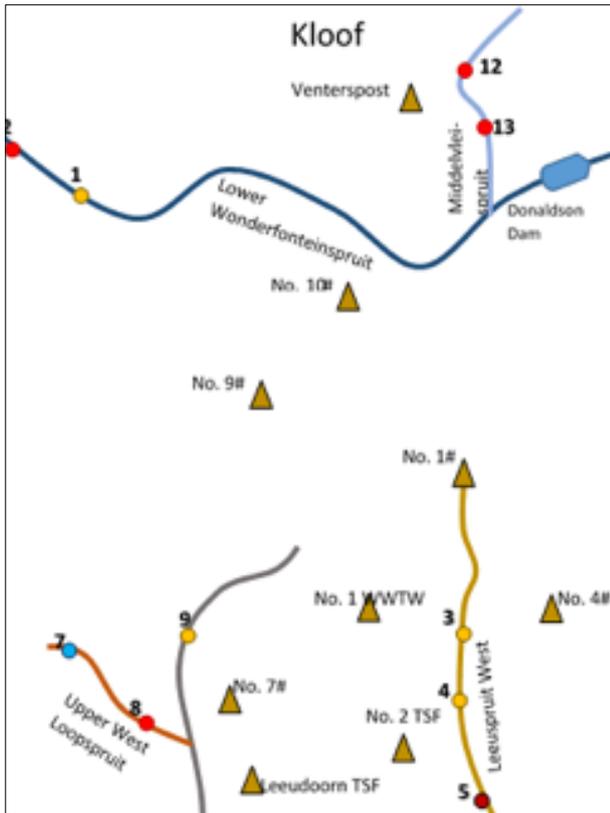
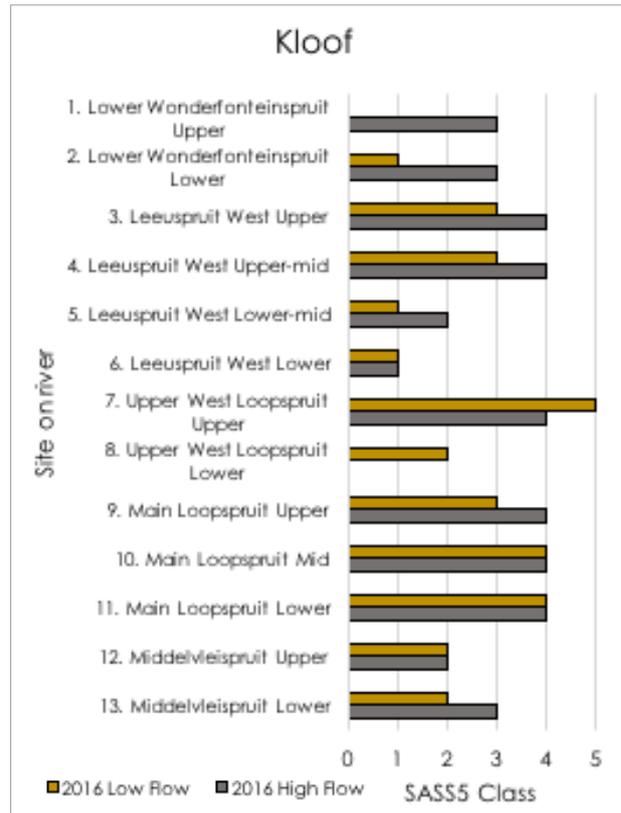
Kloof

Mine	Catchment	Results	Interpretation
KLOOF	Lower Wonderfonteinspruit	Largely modified	<ul style="list-style-type: none"> Habitat significantly impacted by the 1m Ø pipeline* and channels Change in the river's flow route during low flow caused the upstream site to be dry Water quality impacted primarily by sewage inputs but also by mining discharges Habitat alterations due to overgrazing
	Leeuspruit West	Critically to moderately modified	<ul style="list-style-type: none"> Upstream sites in fairly good condition – water quality and habitat partially affected by mining and agriculture Downstream sites severely impacted by overgrazing, resulting in very poor stream condition
	Upper West Loopspruit	Moderately modified to largely natural	<ul style="list-style-type: none"> Reference stream for Upper Vaal sites at Sibanye – not influenced by mining activities Good habitat and water quality Poor results at downstream site due to very limited flow

Main Loopspruit	Moderately modified to largely natural	<ul style="list-style-type: none"> Stream in good condition. Impacts are mainly nutrient-related as a result of mine sewage discharges and agricultural activities Some impact on habitat owing to damming and road crossings
	Middelveispruit	Largely modified	<ul style="list-style-type: none"> Poor stream condition due to altered habitat as a result of illegal mining and informal agriculture Currently, no Sibanye mining activities in catchment area, only dormant workings

* This is a well-known historical pipeline in the Wonderfonteinspruit, installed to prevent flooding of the dolomitic areas to enable mining and reduce the risk of sinkholes in the area.

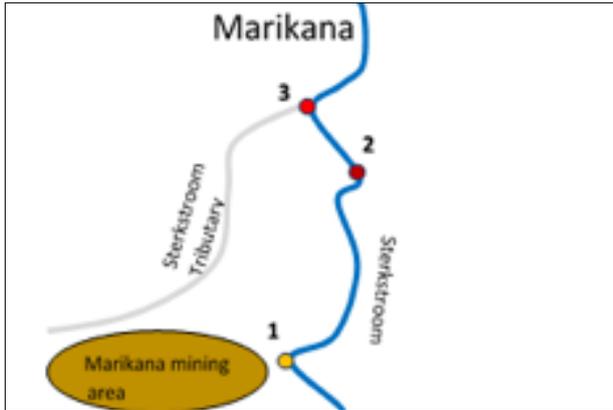
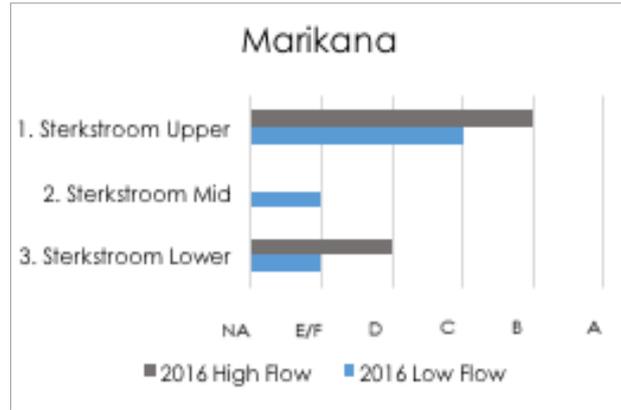
Mine	Catchment	Results	Interpretation
MARIKANA	Olifants River	Moderately modified	<ul style="list-style-type: none"> Low flows in the system were the most likely cause of the poor classes observed at site number 2 The Marikana mine is unlikely to have had an impact

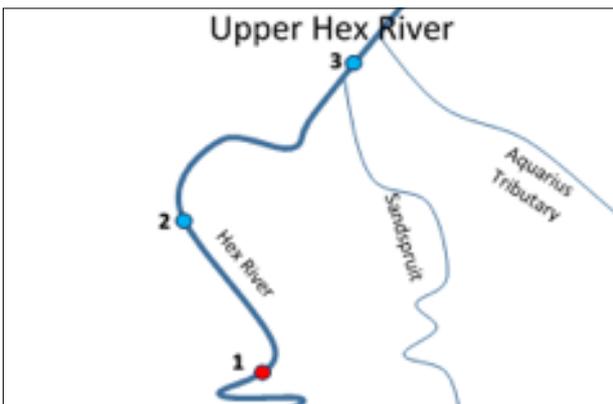
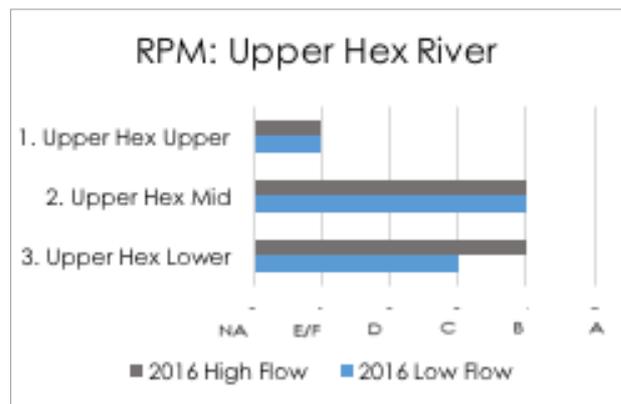
Mine	Catchment	Results	Interpretation
RUSTENBURG OPERATIONS	Upper Hex River	Largely natural	<ul style="list-style-type: none"> River in good condition Upstream site not flowing during assessments, resulting in deteriorated class

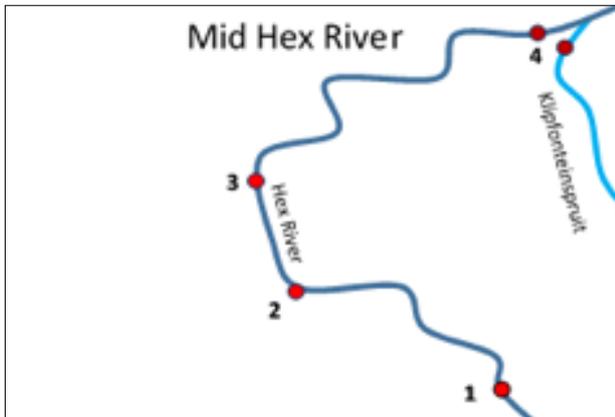
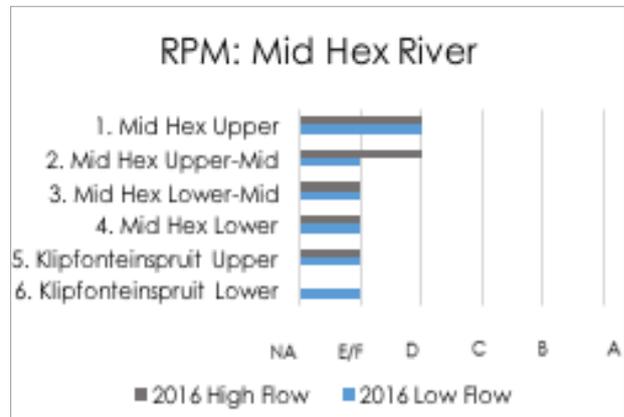
Mine	Catchment	Results	Interpretation
RUSTENBURG OPERATIONS	Mid Hex River	Largely natural	<ul style="list-style-type: none"> Poor habitat availability Water quality may be impacted by surrounding land uses including mining
	Klipfonteinspruit	Critically modified	<ul style="list-style-type: none"> Low flow and very limited habitat availability resulted in low class

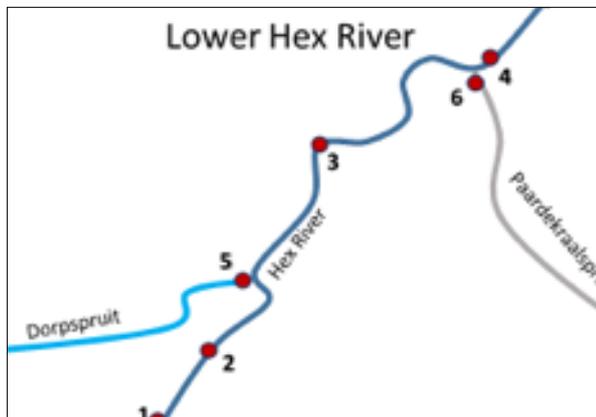
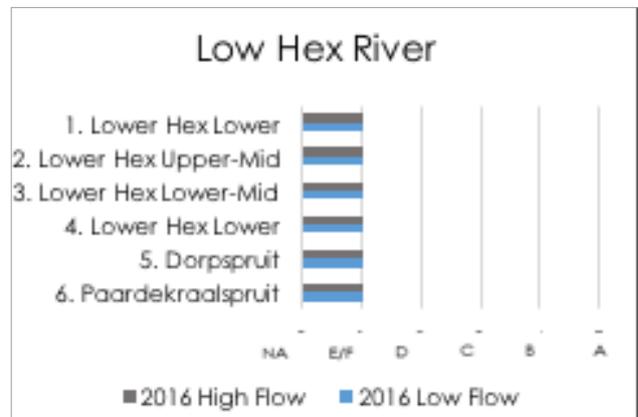
Mine	Catchment	Results	Interpretation
RUSTENBURG OPERATIONS	Lower Hex River	Critically modified	<ul style="list-style-type: none"> Likely impacted by low flows, poor habitat and water quality impacts from mining and non-mining related sources.
	Dorpspruit	Critically modified	<ul style="list-style-type: none"> Attributed as the main source of deterioration in the upper reach of the Lower Hex River.
	PAARDEKRAALSPRUIT	Critically modified	<ul style="list-style-type: none"> Impacts along this stream may be as a result of mining activities but also attributed to other land use activities such as livestock and informal and formal settlements.
